**EDWIN'S HALL
WOODHAM FERRERS
ESSEX**

ARCHAEOLOGICAL EXCAVATION

**8th April – 25th October 2014, and
2nd May – 26th September 2015**

<p>ARCHAEOLOGICAL EXCAVATION</p> <p>Prepared By: Bernie Steel, MAHG Site Manager</p>	<p>Date: 19.02.2025</p>
---	-------------------------

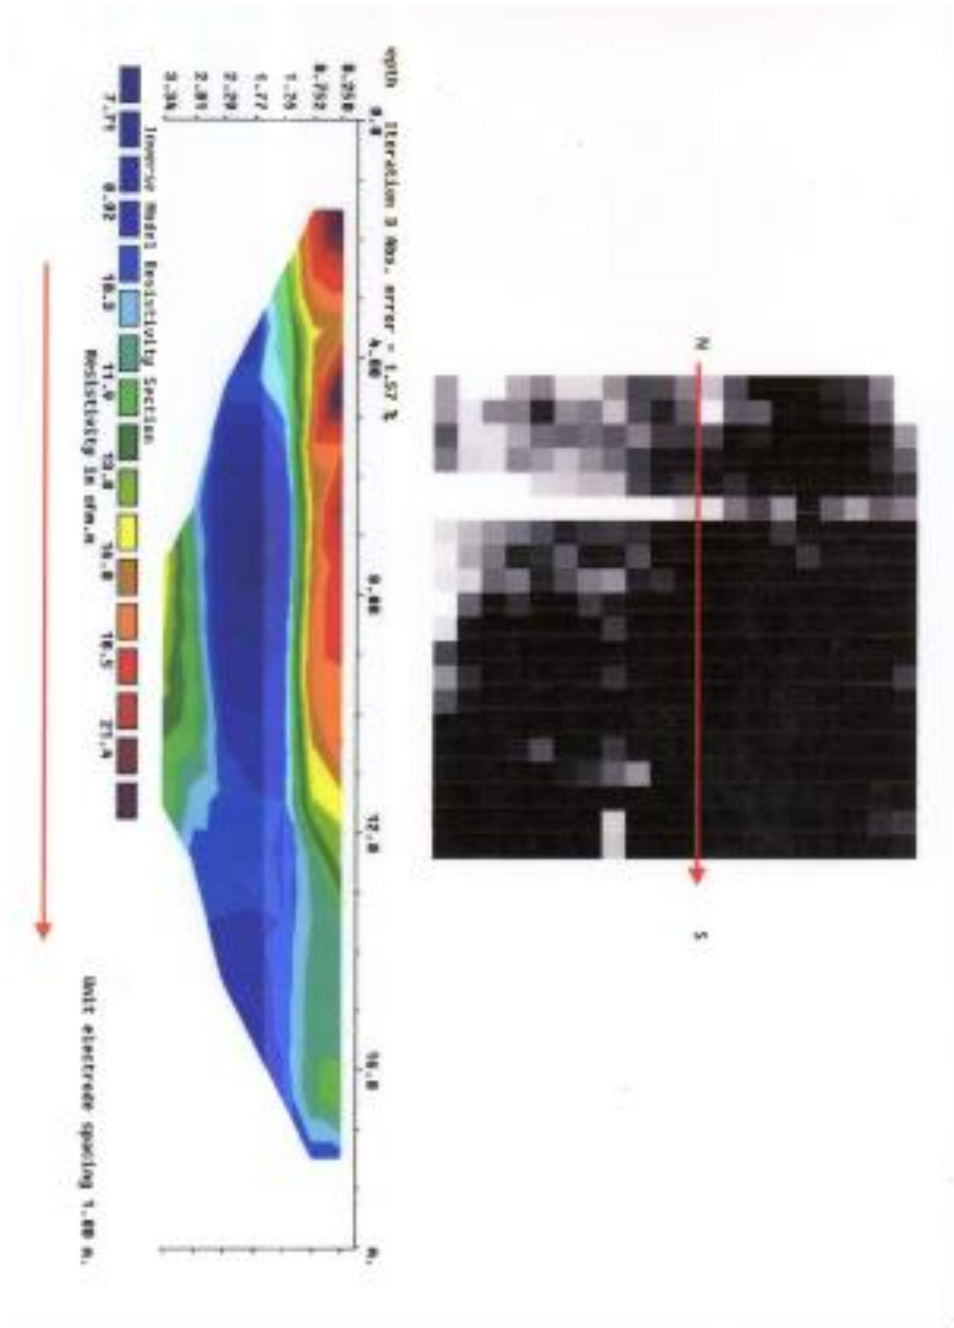
Results of the north to south pseudo-section are shown below:

Two pseudo-sections were also undertaken; one in a north to south direction across the survey grid, the other in a west to east direction.

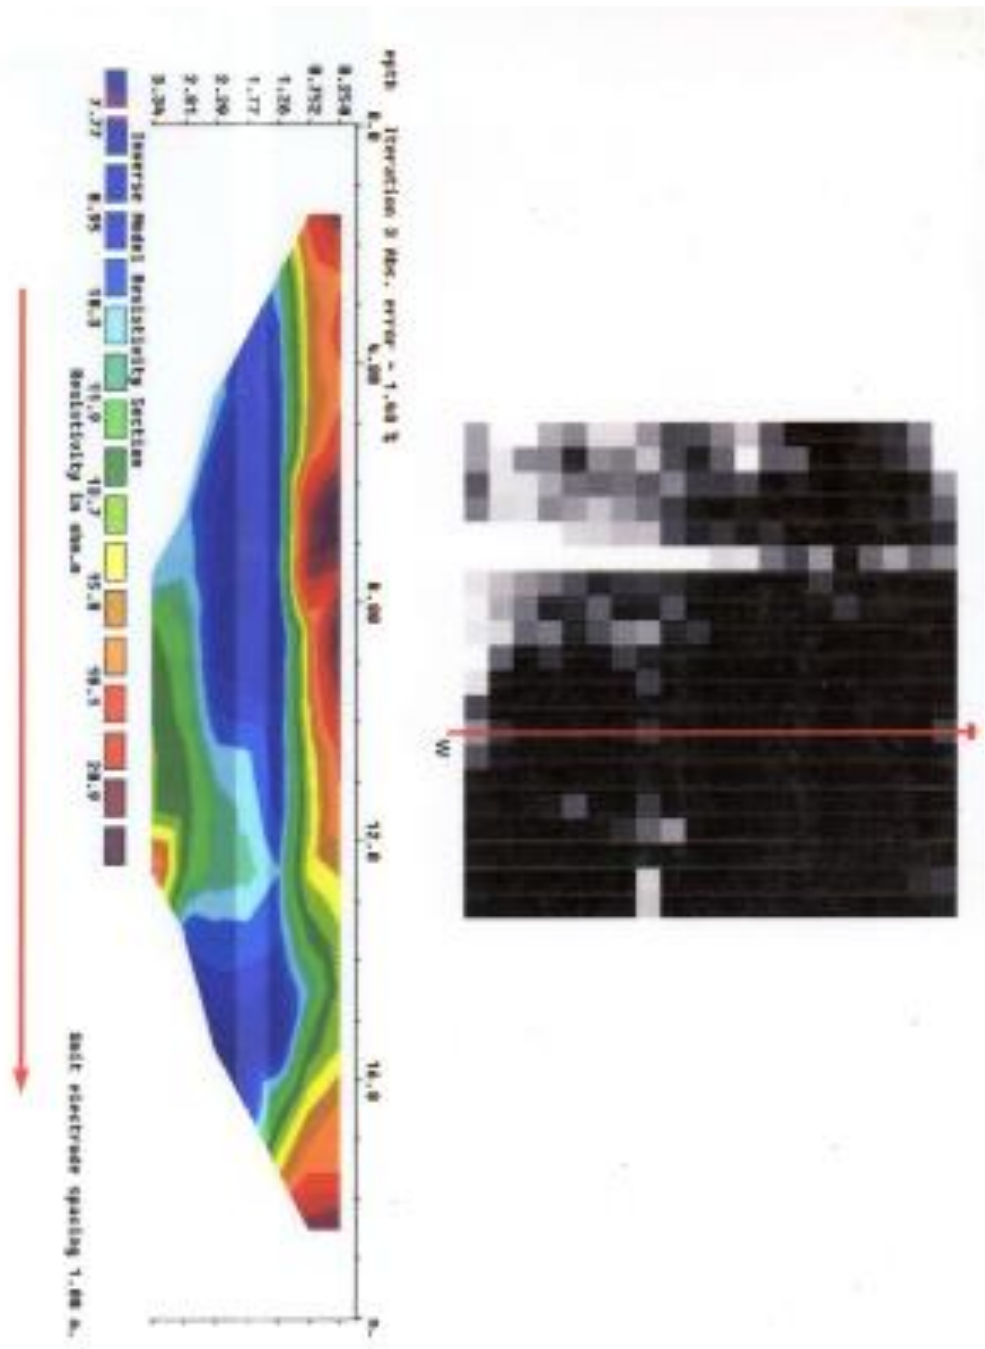
Results of the west to east pseudo-section are shown below:

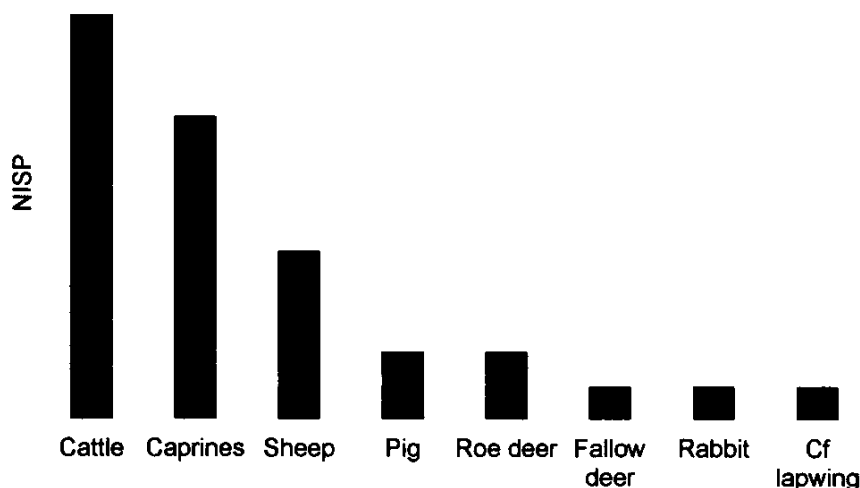
Figure 1: Taxa abundance by NISP

Taxa	NISP
Cattle	12
Caprines	9
Sheep	5
Pig	2
Fallow deer	1
Roe deer	2
Rabbit	1
Large mammal	18
Medium mammal	13
Cf lapwing	1
Indeterminate	7
<i>Total</i>	<i>71</i>

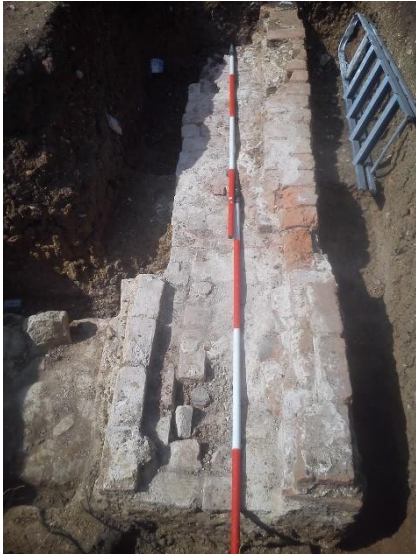
Fig 1: EH1 South to North View-Underlying Structure Bottom Left.

- At a depth of 100 mm the sondage provided evidence of the nature and extent of the wall foundation and subsequently led to the exposure of an irregular stone structure which ran in line with the front of the existing Tudor manor house and at 90° toward and under the post medieval wall foundations. This underlying structure measured approximately 810 mm wide and did not reappear on the eastern side of the Tudor wall foundation. The mixed construction materials of this underlying feature included Kentish Ragstone. It is suggested that this underlying structure is likely to have been the foundations of an earlier manor house on the site.

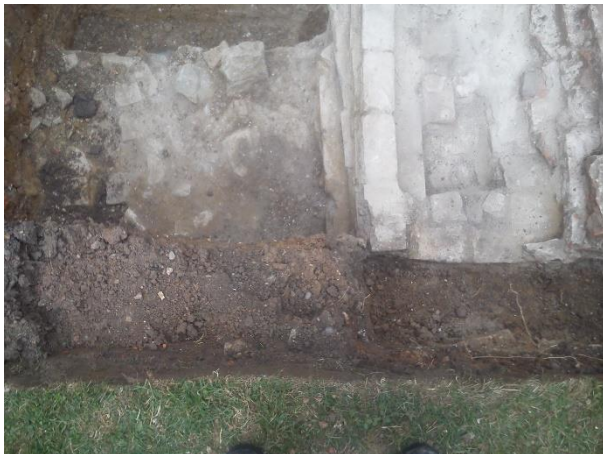
Fig 2: South End of EH1 Showing Terminal and Underlying Structure.

- The southern end of the wall in EH1 ended in a significant mass of brickwork with no apparent connection to the wall remains in trench EH3.

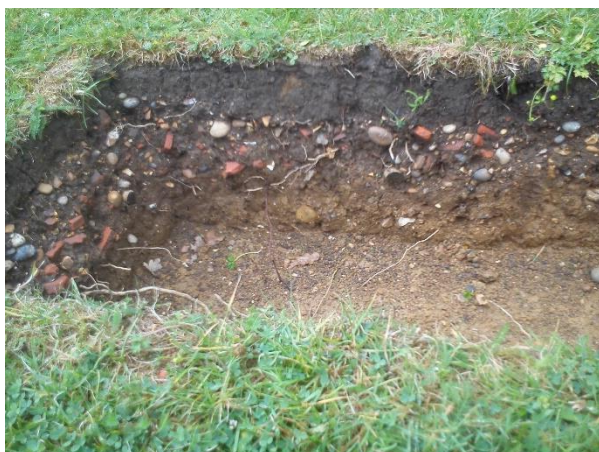
Fig 3: EHTP2/EH2 North Horizon showing the three contexts; topsoil, demolition layer, clay natural.

- On excavating through a shallow layer of demolition material the excavation reached natural clay. The trench was recorded, closed-down and back filled.

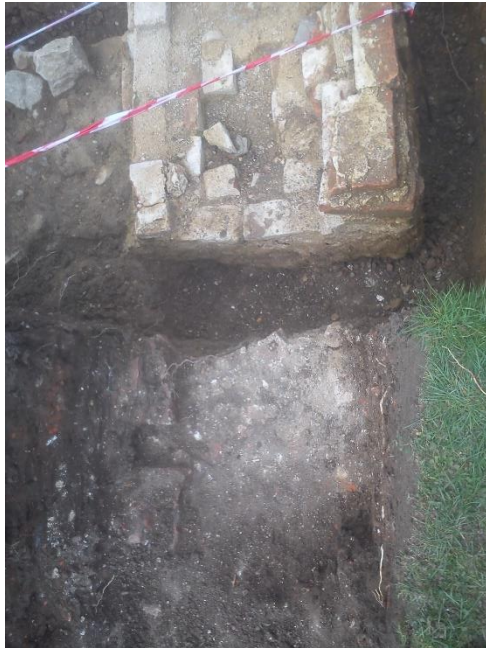
Fig 4: EH3 North EH4 South cut through.

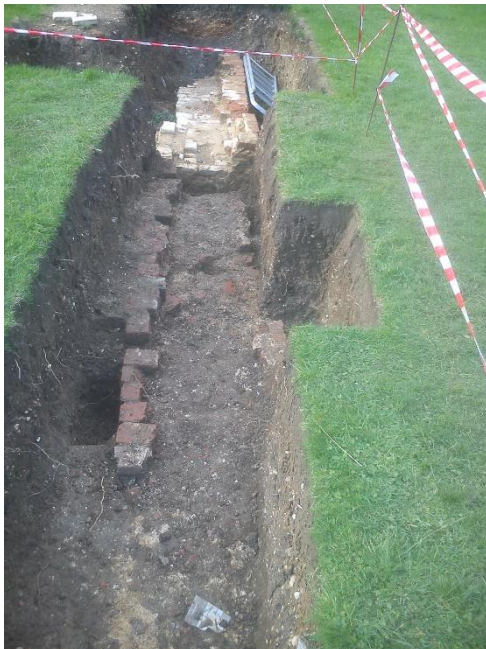
Fig 5: EH3 South to North.

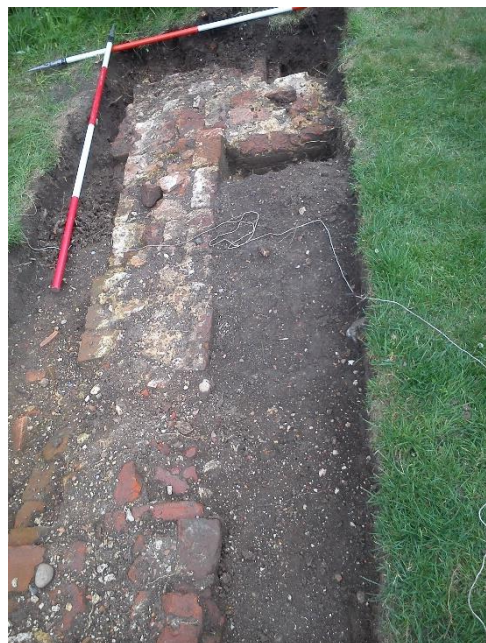
Fig 6: EH3 South.

- The southern extremity of the north-south wall was very close to the inner moat. The southern end of the wall culminated in a large buttress wrapping around the south-east corner. A return wall, heading to the west, can be seen at the bottom of the photograph in Appendix 12.

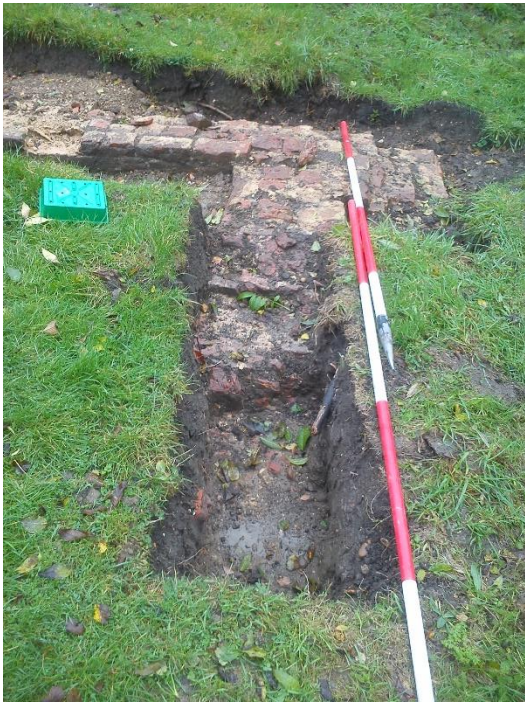
Fig 7: EH3 south west extension looking east.

- At the southern end, the wall was found to return in a westerly direction which can be taken to be the southern elevation of the demolished east wing.

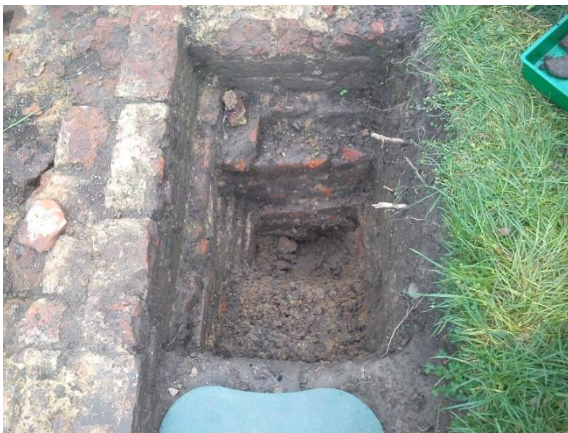
Fig 8: EH3 south west junction of the north-south wall and the westerly return; a sondage inserted in the south end of EH3 indicated that there are between 13 and 16 courses of brickwork in-situ (the higher number being on the inner moat side of the wall).

- A sondage inserted in the south end of EH3 indicated that there are between 13 and 16 courses of brickwork in-situ (the higher number being on the moat side of the wall). Further investigation came to an end as at that depth as the excavation began to fill with groundwater.
